County of San Mateo - Planning and Building Department

SUNRISE REDWOOD CITY

ASSISTED LIVING FACILITY

REDWOOD CITY, CA

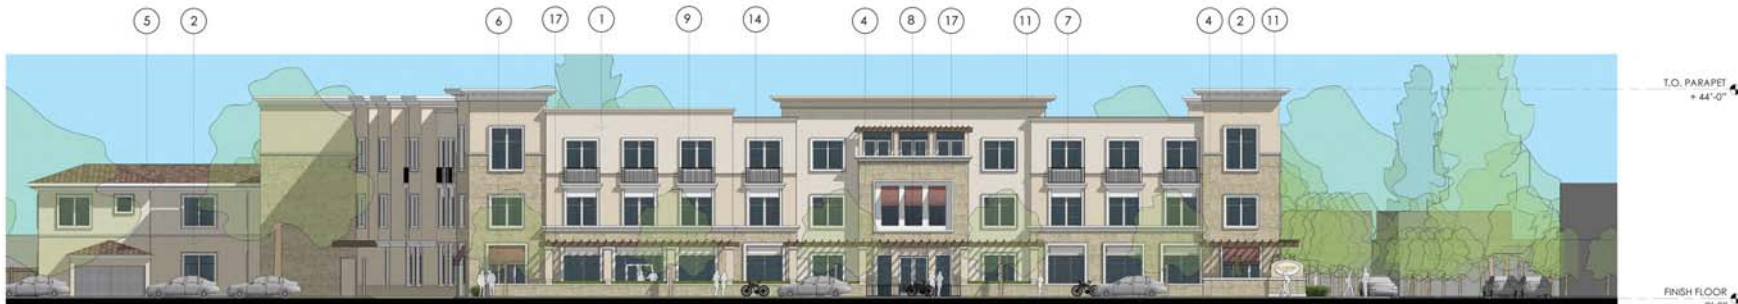
VIEW FROM EL CAMINO REAL (SOUTH ELEVATION)

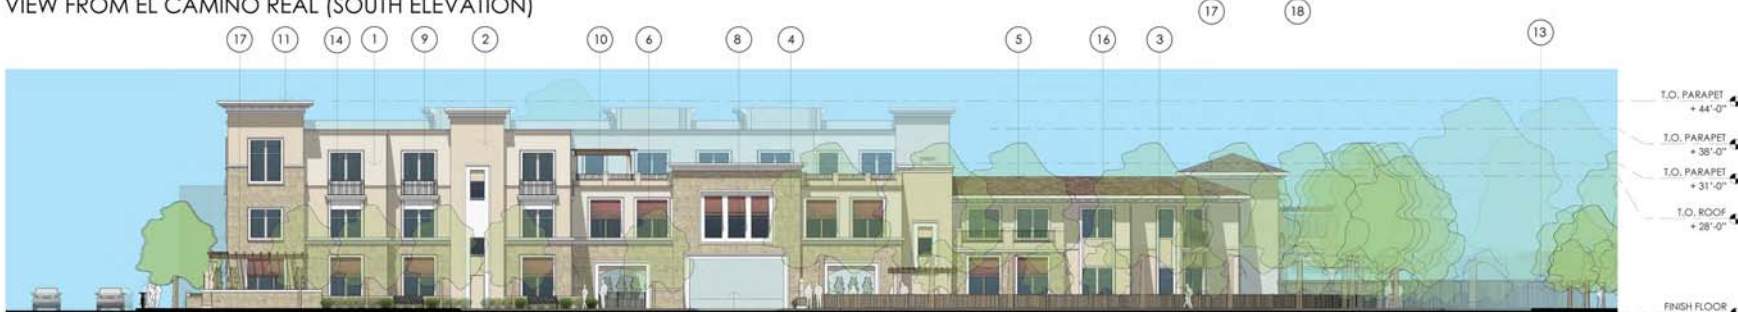
VIEW FROM SELBY (EAST ELEVATION)

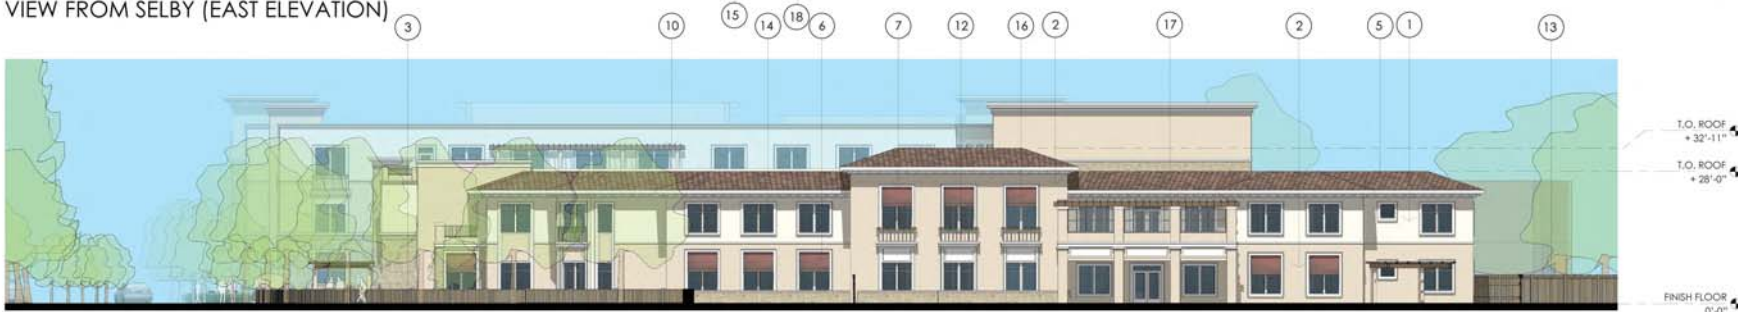
VIEW FROM MARKHAM (NORTH ELEVATION)

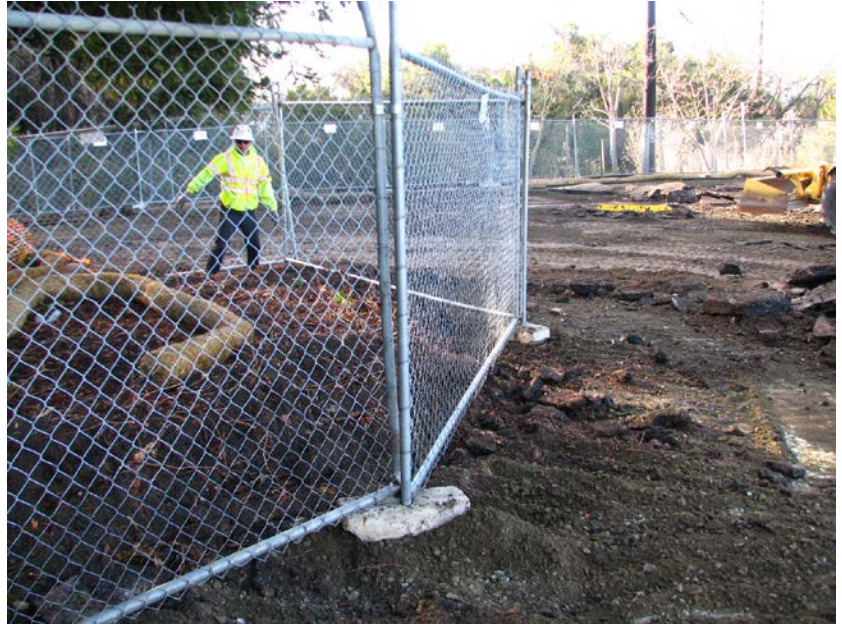
Erect five-foot tall chain link fence on seven-foot long, two-inch diameter iron tube posts pounded 24 inches into the ground. Alternatively, use chain link fence panels set on small moveable concrete block footings and affixed to rebar or steel layout stakes pounded into the ground at the end of each fence panel to make the fence perimeters rigid and immobile (see sample image at right).

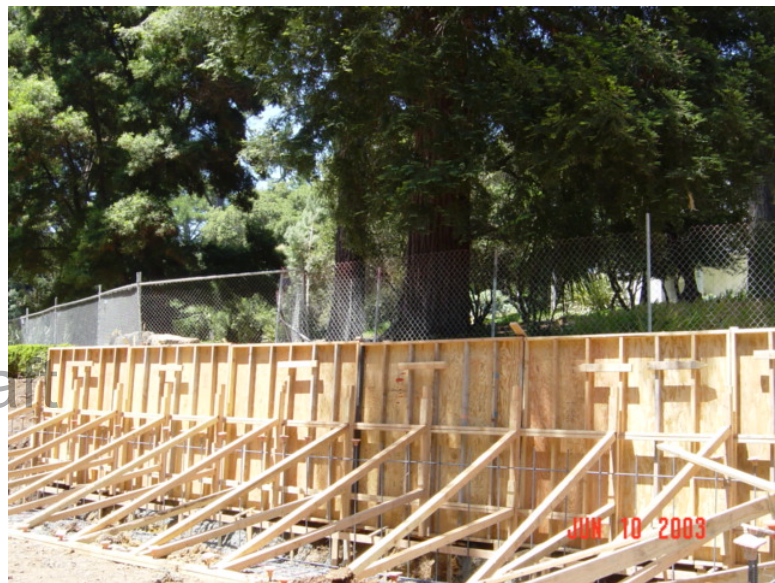
It is suggested that the project team consider modification of the proposed building footprint exterior foundation work limit, and the underground parking garage excavation work limit which coincides exactly with the building exterior. The modification suggested is a push to the south and/or west to allow for better lateral offset distance between the oaks' root systems and the excavation cut which will destroy 100% of all lateral woody and absorbing root mass at that distance.

A suggested minimum distance is 25 to 30 feet from excavation cut to tree trunks.

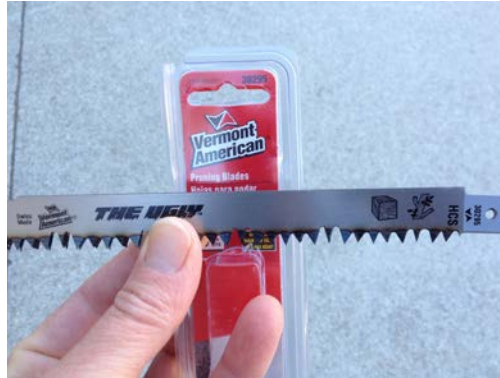
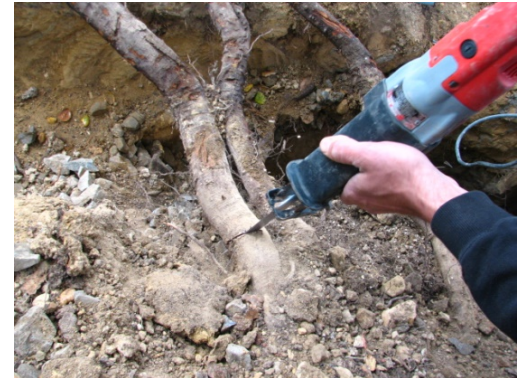
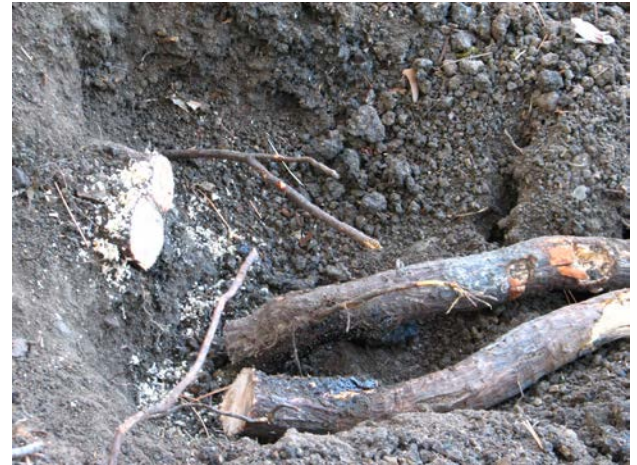
If woody roots measuring greater than 1-inch in diameter are encountered within 25-feet of any tree being retained during site work, contractors shall immediately alert the project arborist, and shall proceed to sever roots at right angles to the direction of root

growth using sharp hand tools such as professional grade loppers, hand shears, chain saw, A/C sawzall, or other tools only under his/her direct supervision. See spec images at right. Note that a Sawzall blade indicating use for "bimetal" or "demolition" is typically not a good choice for this work. Instead, opt for a relatively large-toothed blade that indicates use for "pruning" or "wood" (see images at right).

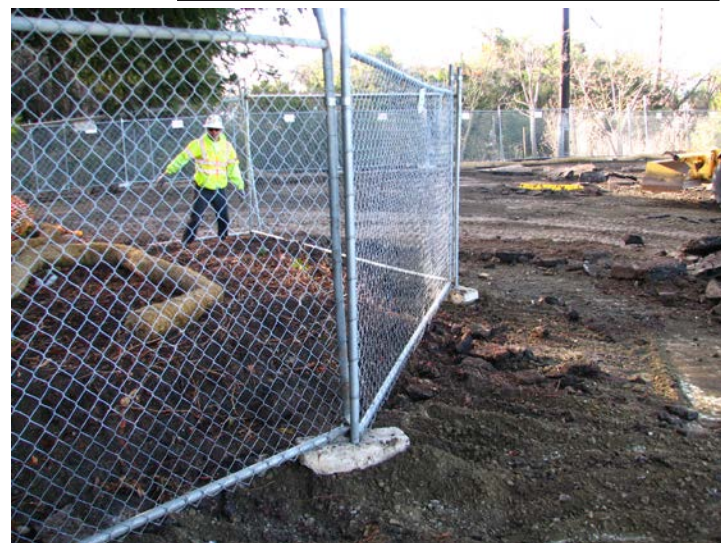
Erect five-foot tall chain link fence on seven-foot long, two-inch diameter iron tube posts pounded 24 inches into the ground. Alternatively, use chain link fence panels set on small moveable concrete block footings and affixed to rebar or steel layout stakes pounded into the ground at the end of each fence panel to make the fence perimeters rigid and immobile (see sample image at right).

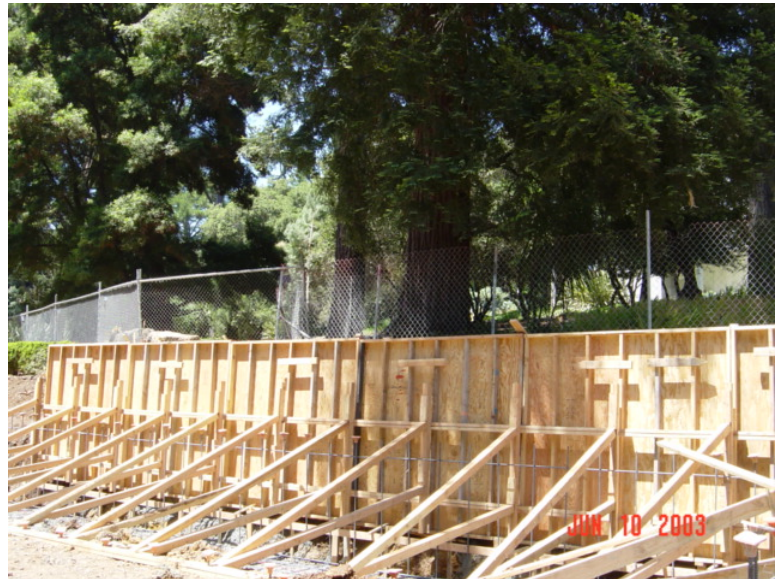
Use of vertical shoring is the preferred alternative to use of an OSHA layback cut. Shoring can be used to hold up the soil in a safe manner for construction personnel while the garage area is built below grade.

See WLCA's sample image above right showing vertical wooden shoring we used at College of Notre Dame to save a large redwood tree specimen adjacent to a retaining wall cut. Because the OSHA layback type cut was eliminated on this project, we were able to preserve most of this tree's root system, and it survived easily.

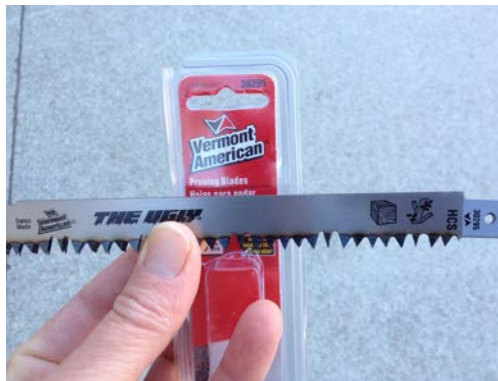
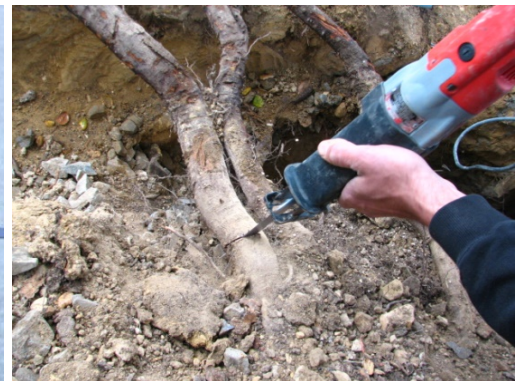
If **woody roots measuring greater than 1-inch in diameter** are encountered within 25-feet of any tree being retained during site work, contractors shall immediately alert the project arborist, and shall proceed to sever roots at right angles to the direction of root growth using sharp hand tools such as professional grade loppers, hand shears, chain saw, A/C sawzall, or other tools only under his/her direct supervision. See spec images at right. Note that a Sawzall blade indicating use for "bimetal" or "demolition" is typically not a good choice for this work. Instead, opt for a relatively large-toothed blade that indicates use for "pruning" or "wood" (see images at right).

Woody roots shall not be shattered or broken in any way as a result of site activities. Shattered or broken areas shall be hand dug back into clear healthy root tissue and re-severed at right angles to root growth direction under the direct supervision of the project arborist (PA). Immediately (same day) backfill over roots and heavily irrigate (same day) after backfill to saturate the uppermost 24 inches of the soil profile.

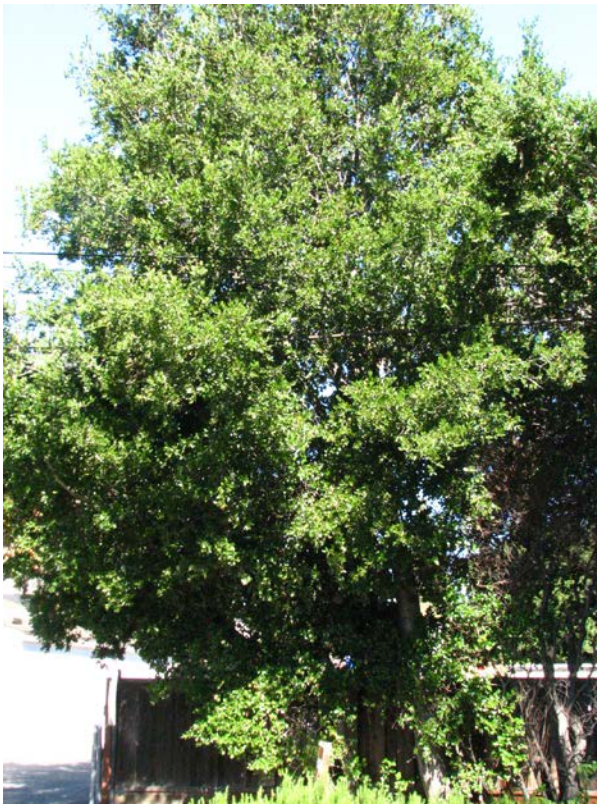
13, 14

North view of oaks 10, 11, 12, 13, & 14 extend -ed south and west into the (e) lot.

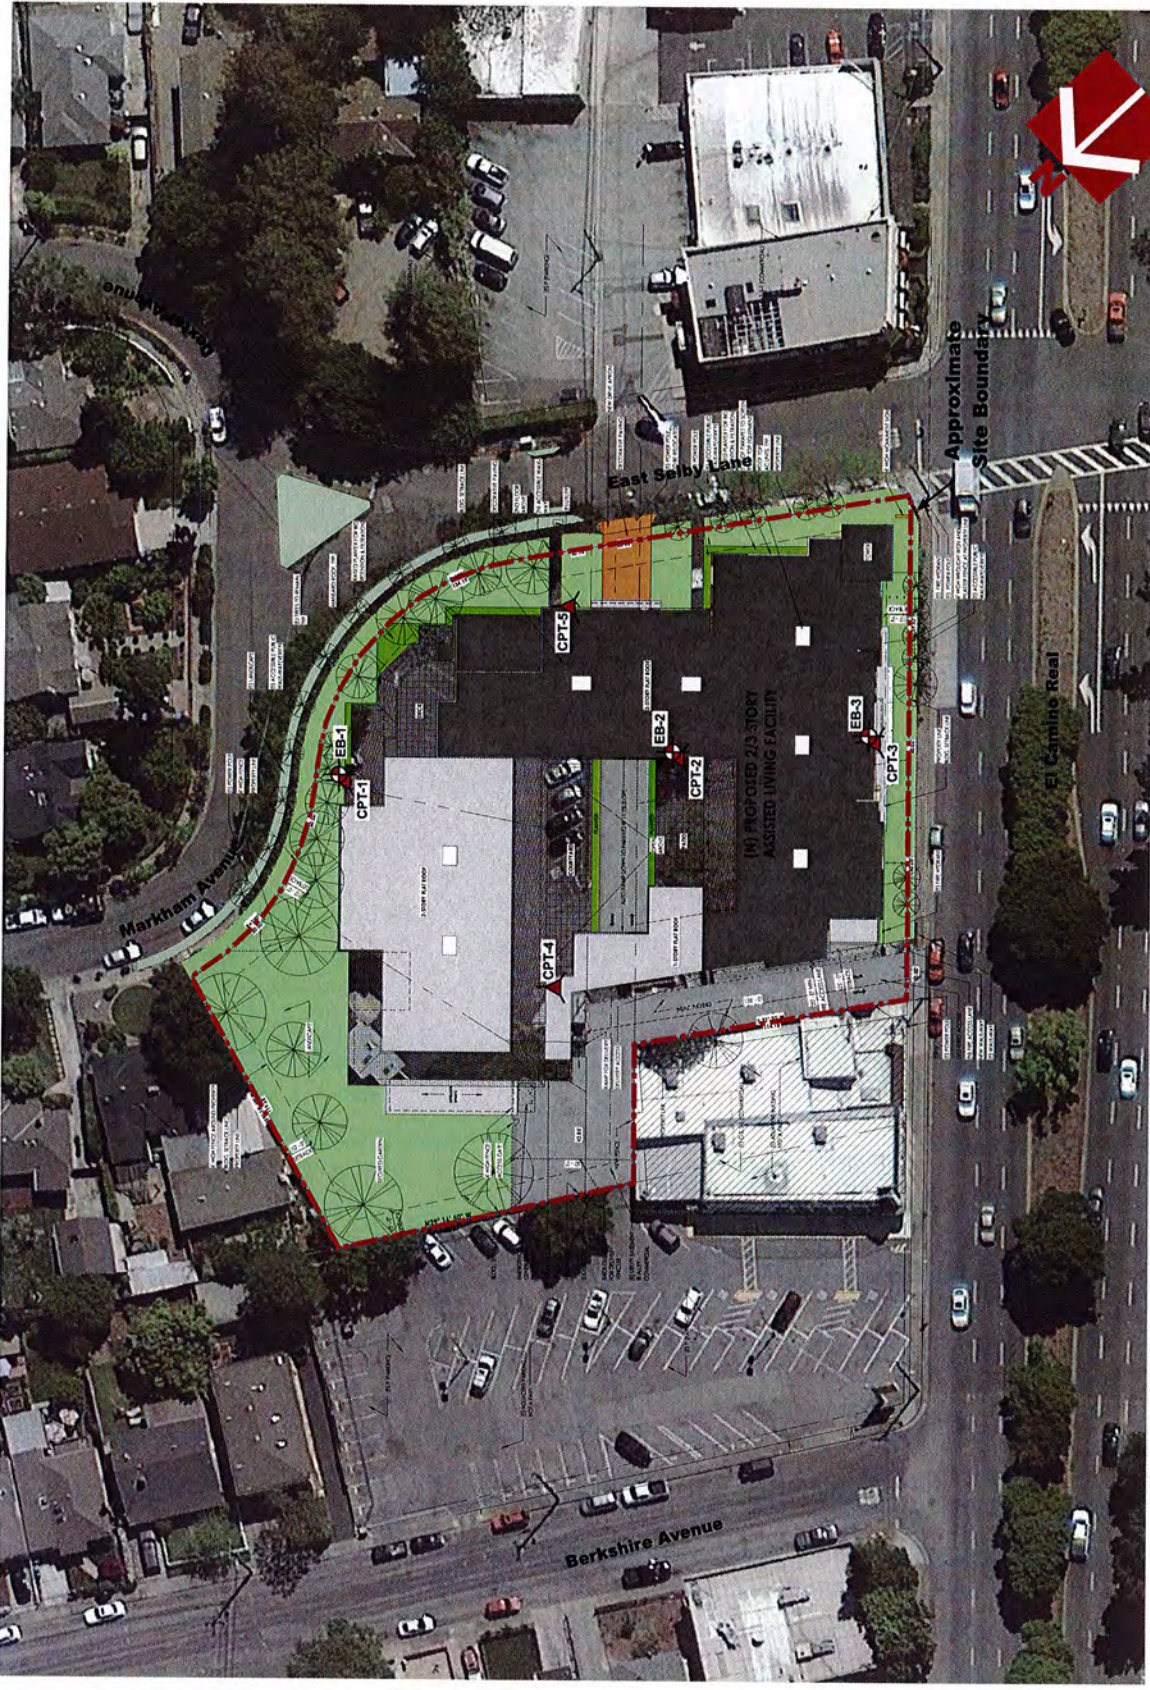
- Approximate location of exploratory boring (EB)
- Approximate location of cone penetration test (CPT)

Base by Google Earth, dated 4/5/2016
Overlay by HPI Architecture, Conceptual Site Plan - A1.0 - 12/5/2016
