**COUNTY OF SAN MATEO - PLANNING AND BUILDING DEPARTMENT**

**RE: 222 Portola State Park Road  
La Honda, CA 94020**

**GEOLOGIC AND GEOTECHNICAL INVESTIGATION**

BEIGELMAN RESIDENCE

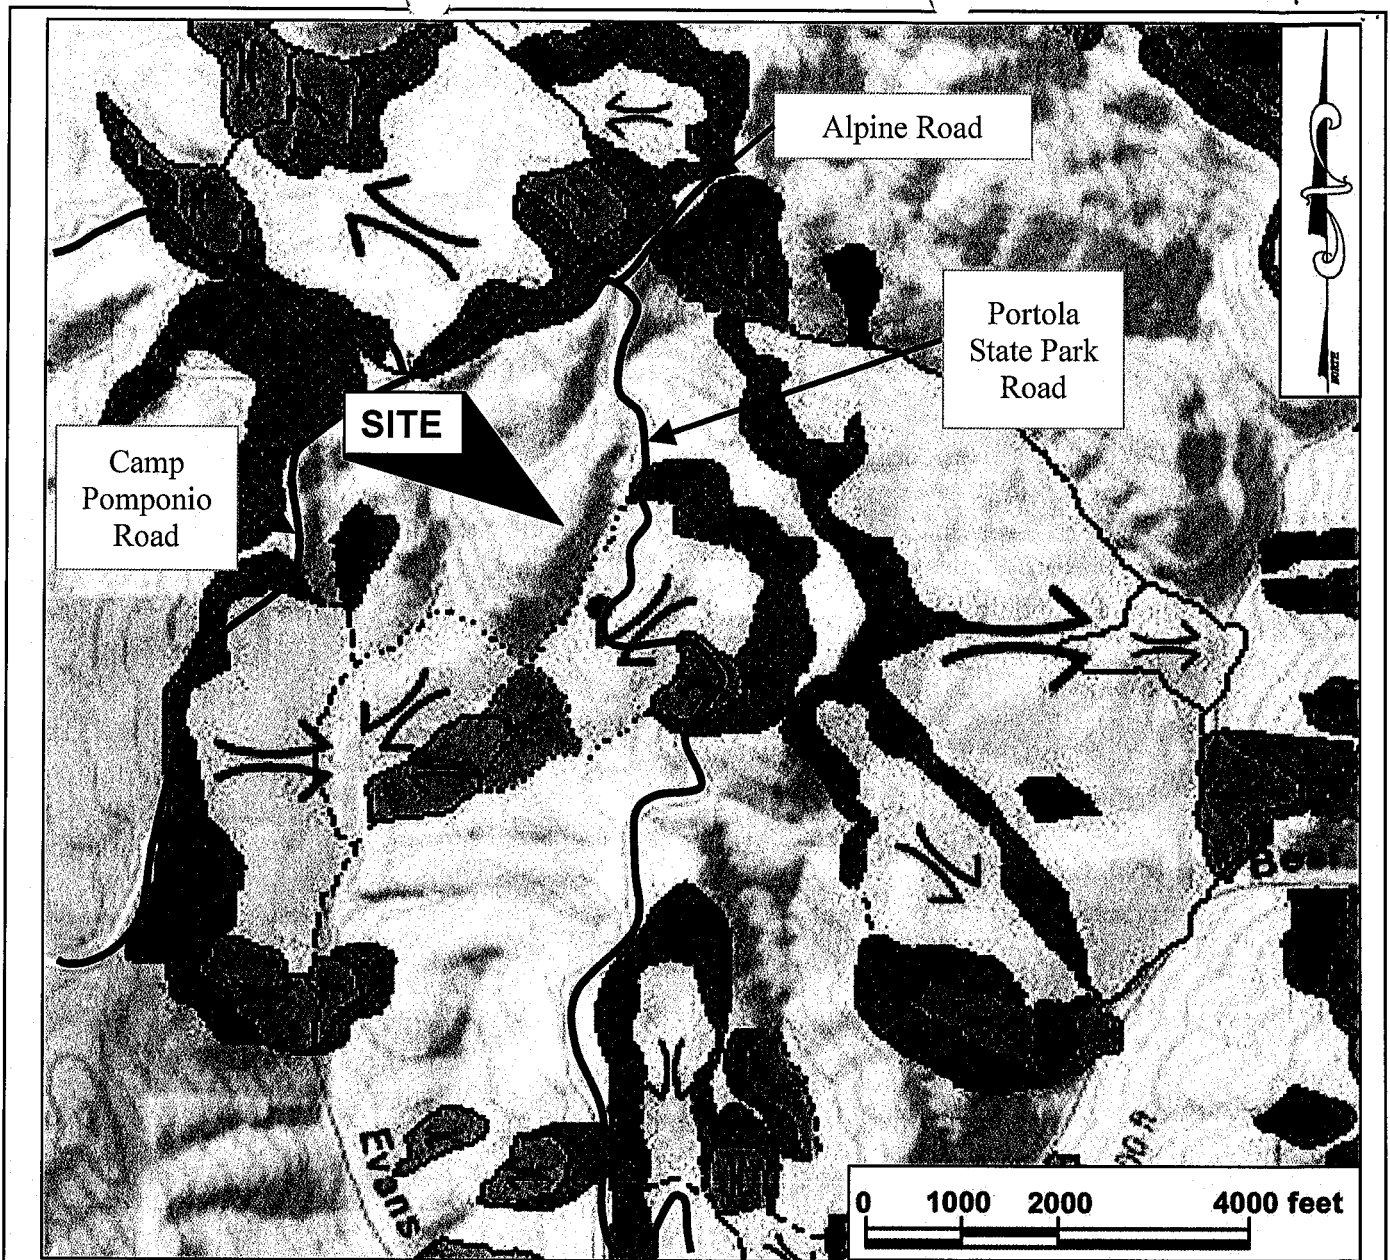
**FIGURE 5**  
**JUNE 2019**  
**PROJECT NO. 4779-1**

**LANDSLIDE INVENTORY BETA MAP (CGS)**  
**BEIGELMAN RESIDENCE**  
**LA HONDA, CALIFORNIA**

The landslide inventory beta (map) prepared by the California Geological Survey (CGS, 2019) shows dormant mature and old/relict landslides on the sloping terrain of adjacent knolls and hills. The location of the proposed residence and improvements appear to be located outside the limits of both the landslides and landslide source areas shown by CGS (Figure 5). In addition, there are no landslide or landslide sources mapped upslope of the proposed improvements.

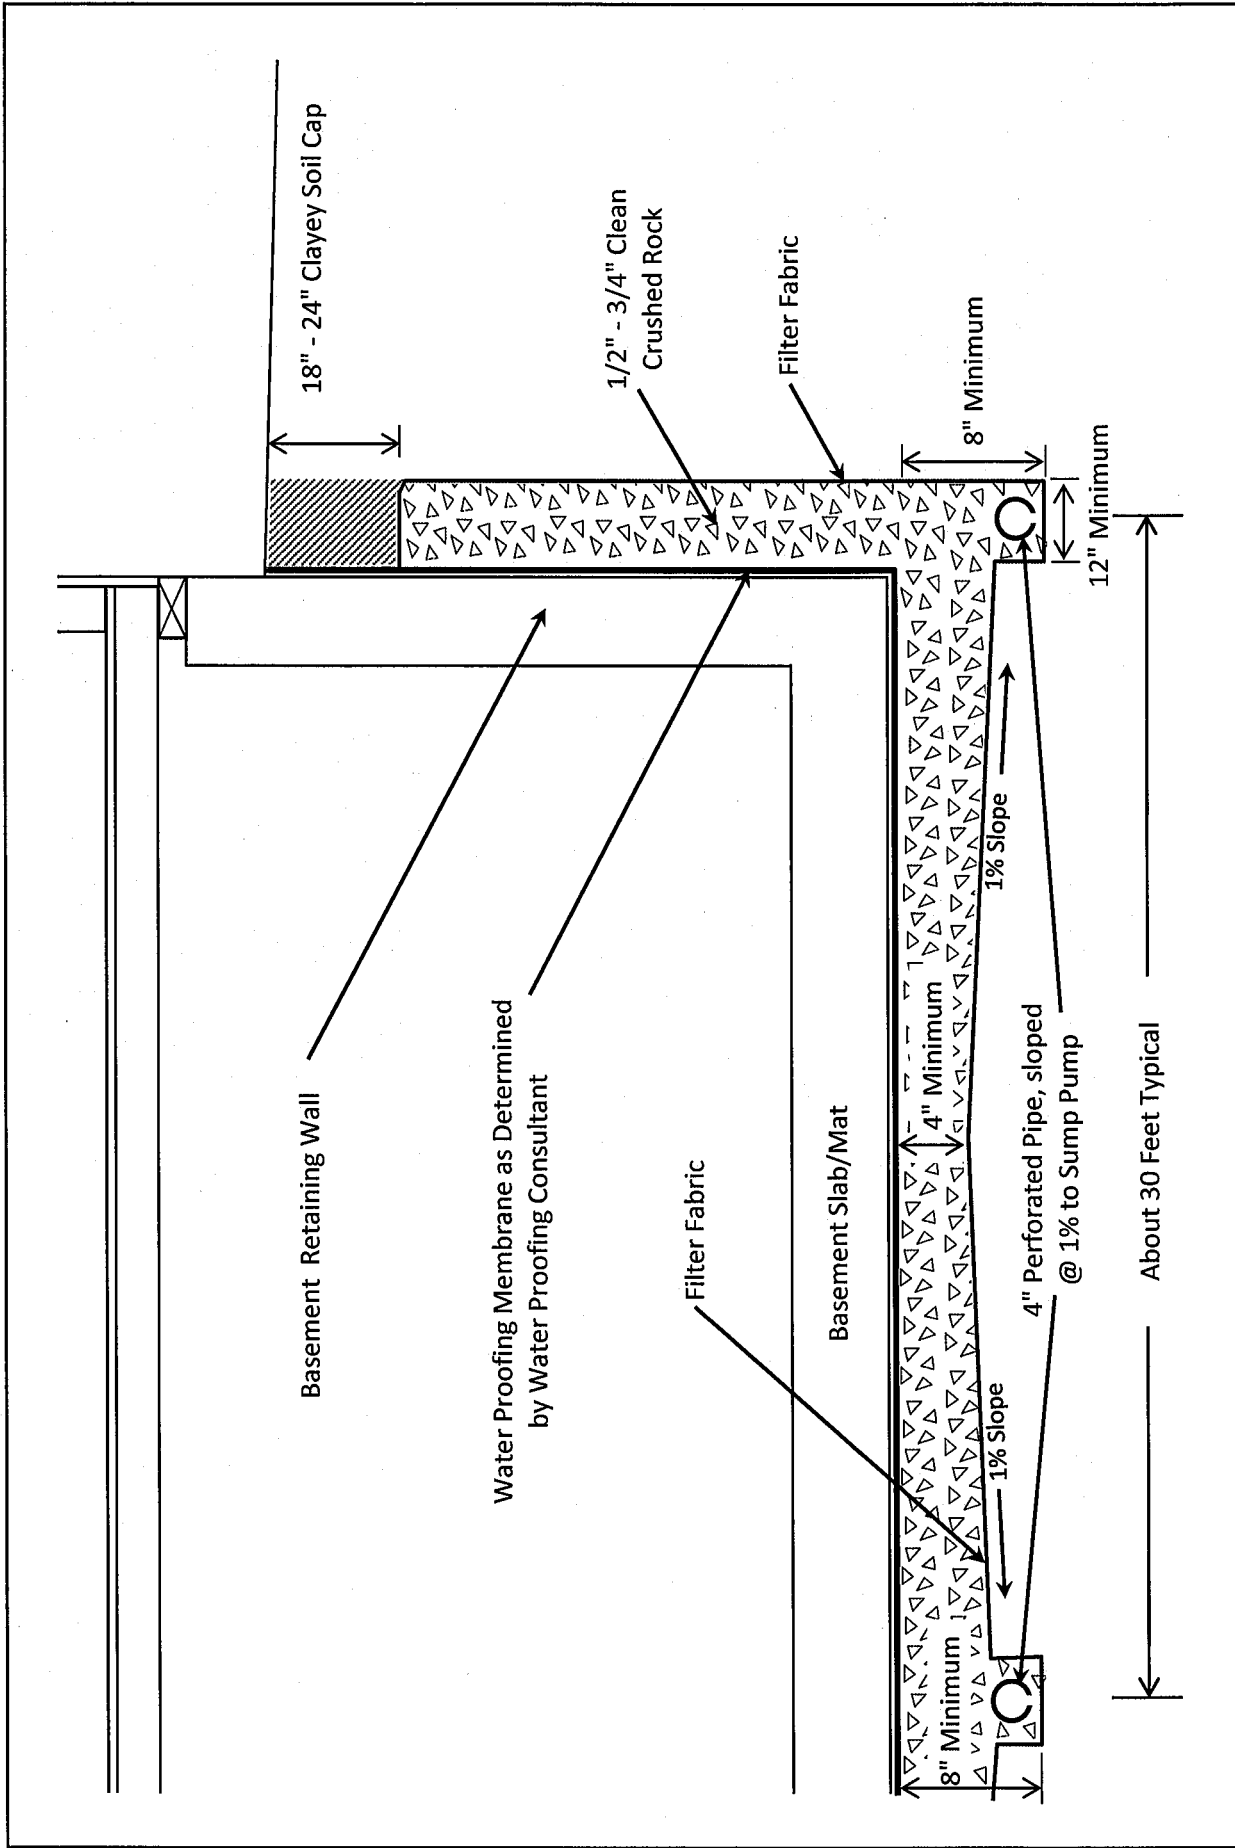
**FIGURE 7**  
 JUNE 2019  
 PROJECT NO. 4779-1

**SUBSLAB DRAINAGE DETAIL**  
 BEIGELMAN RESIDENCE  
 LA HONDA, CALIFORNIA

If a slab underdrain is installed, perforated pipes for the underdrain should be installed at the bottom of the excavation. The floor drainage system should include a minimum 4- to 8-inch-thick blanket of free-draining gravel, such as 1/2- or 3/4-inch crushed rock with no more than 5 percent passing the ASTM No. 200 sieve, below the mat/slab. Prior to placing the gravel blanket, the subgrade below the gravel layer should be surface compacted and covered with filter fabric, such as TC Mirafi 140N. The gravel drain should extend up and around the sides of the foundation and basement walls. Drain pipes around the basement walls should consist of 4-inch diameter perforated PVC pipes with perforations placed down installed at bottom of the wall excavation. The perforated pipes should discharge to a suitable outfall location. To minimize vapor transmission through the floor slab, a high-quality water-proof membrane designed by the water proofing consultant should be placed over the crushed rock and around the edges of the mat foundation. A schematic sketch of the subslab drainage system is presented in Figure 7.

To prevent buildup of water pressure from surface water infiltration, a subsurface drainage system should be installed behind the walls. The drainage system should consist of a 4-inch diameter perforated pipe (perforations placed down) embedded in a section of 1/2- to 3/4-inch, clean, crushed rock at least 12 inches wide. Backfill above the perforated drain line should also consist of 1/2- to 3/4-inch, clean, crushed rock to within about 1 1/2 to 2 feet below exterior finished grade. A filter fabric should be wrapped around the crushed rock to protect it from infiltration of native soil. The upper 1 1/2 to 2 feet of backfill should consist of compacted native soil. The perforated pipe should discharge into a free-draining outlet or sump that pumps to a suitable location. Damp-proofing of the walls should be included in areas where wall dampness and efflorescence would be undesirable. A diagrammatic section illustrating a typical drainage system for the basement is shown on Figure 7.

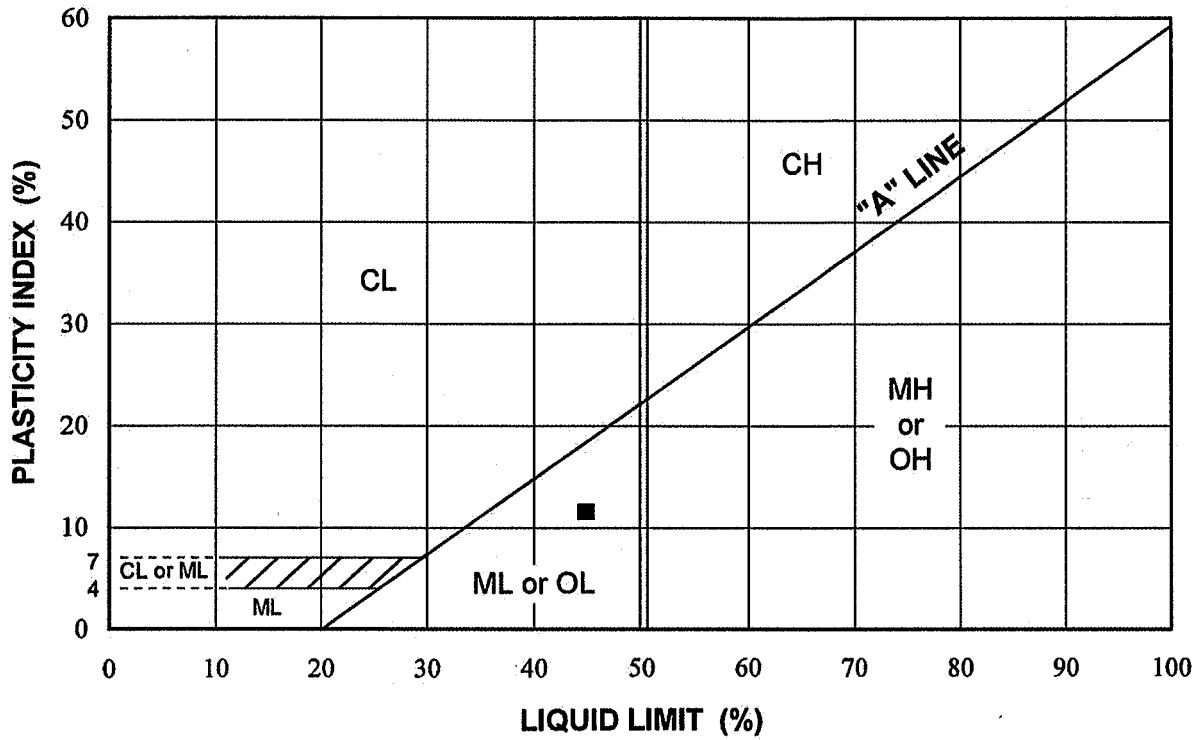
Chart Symbol	Boring Number	Sample Depth (feet)	Water Content (percent)	Liquid Limit (percent)	Plasticity Index (percent)	Liquidity Index (percent)	Passing No. 200 Sieve (percent)	USCS Soil Classification
■	EB-5	0.5-2	39	45	12			ML

PLASTICITY CHART  
 BEIGELMAN RESIDENCE  
 LA HONDA, CALIFORNIA

The Atterberg Limits were determined on one sample of soil in accordance with ASTM D4318. The Atterberg Limits are the moisture content within which the soil is workable or plastic. The results of this test are presented in Figure B-1 and on the log of Boring EB-5 at the appropriate sample depth.

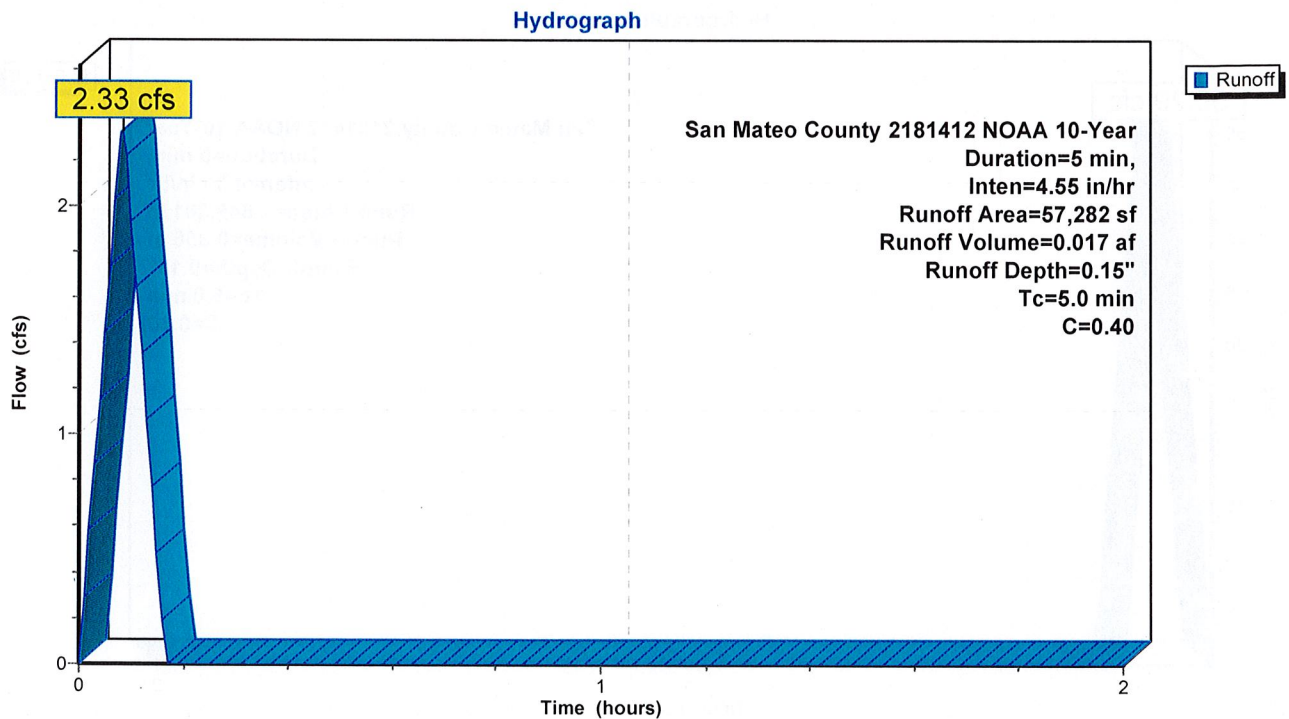
**Subcatchment Post 10 Year B: 10 Year Post-Construction Retained**

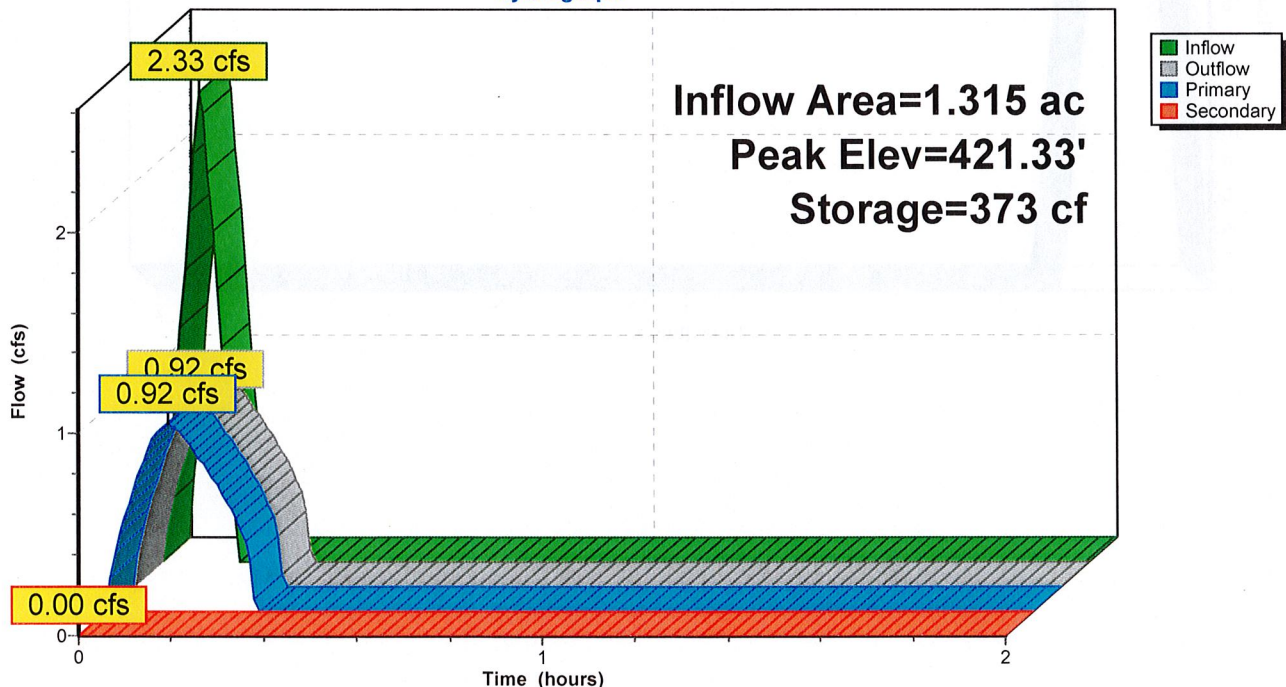
Inflow Area = 1.315 ac, 0.00% Impervious, Inflow Depth = 0.15" for 10-Year event  
 Inflow = 2.33 cfs @ 0.08 hrs, Volume= 0.017 af  
 Outflow = 0.92 cfs @ 0.13 hrs, Volume= 0.017 af, Atten= 60%, Lag= 3.1 min  
 Primary = 0.92 cfs @ 0.13 hrs, Volume= 0.017 af  
 Secondary = 0.00 cfs @ 0.00 hrs, Volume= 0.000 af

### Pond 1: Retention

Hydrograph

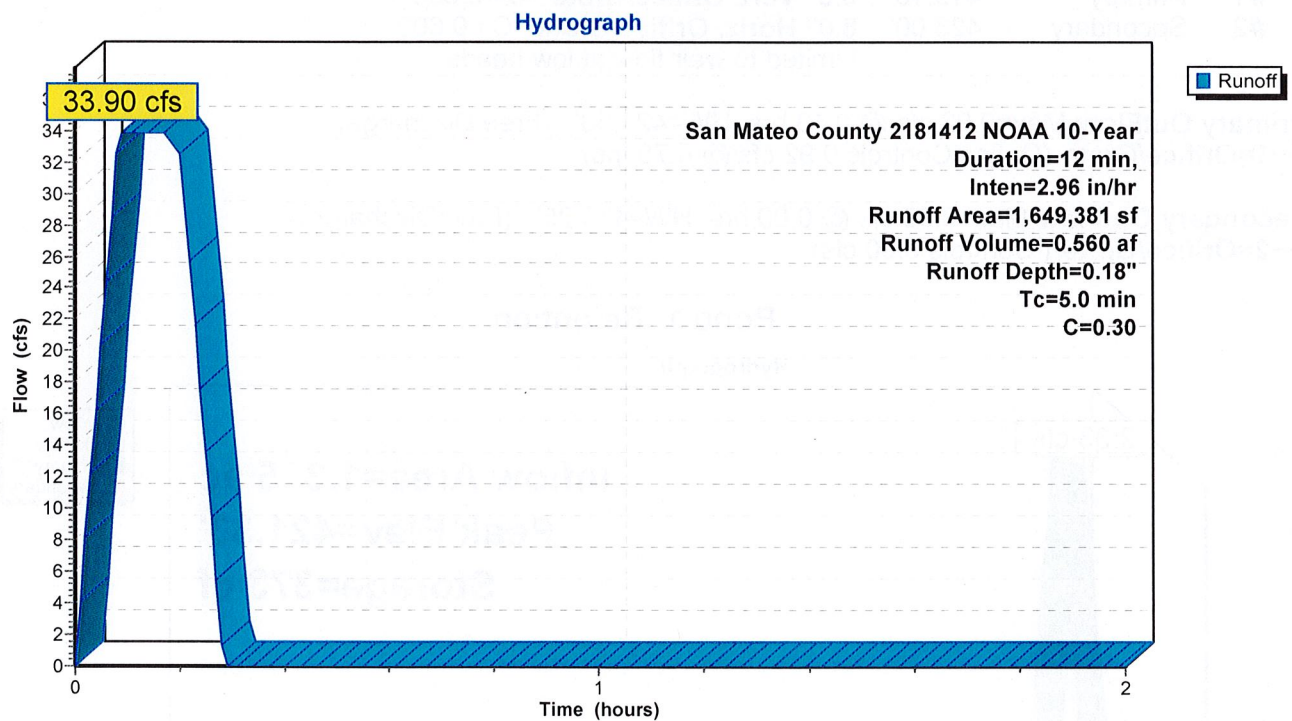
Runoff = 33.90 cfs @ 0.09 hrs, Volume= 0.560 af, Depth= 0.18"

**Subcatchment Post 10 Year A: 10 Year Post-Construction Unretained**

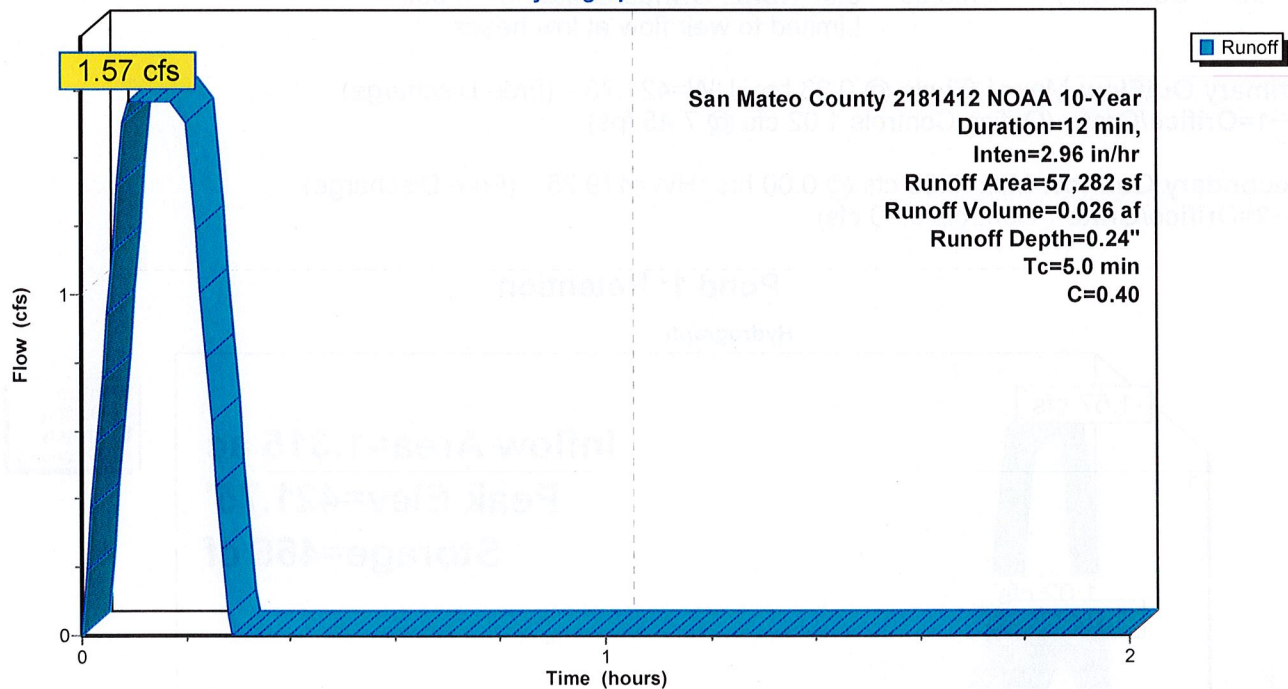
Runoff = 1.57 cfs @ 0.09 hrs, Volume= 0.026 af, Depth= 0.24"

**Subcatchment Post 10 Year B: 10 Year Post-Construction Retained**

Hydrograph

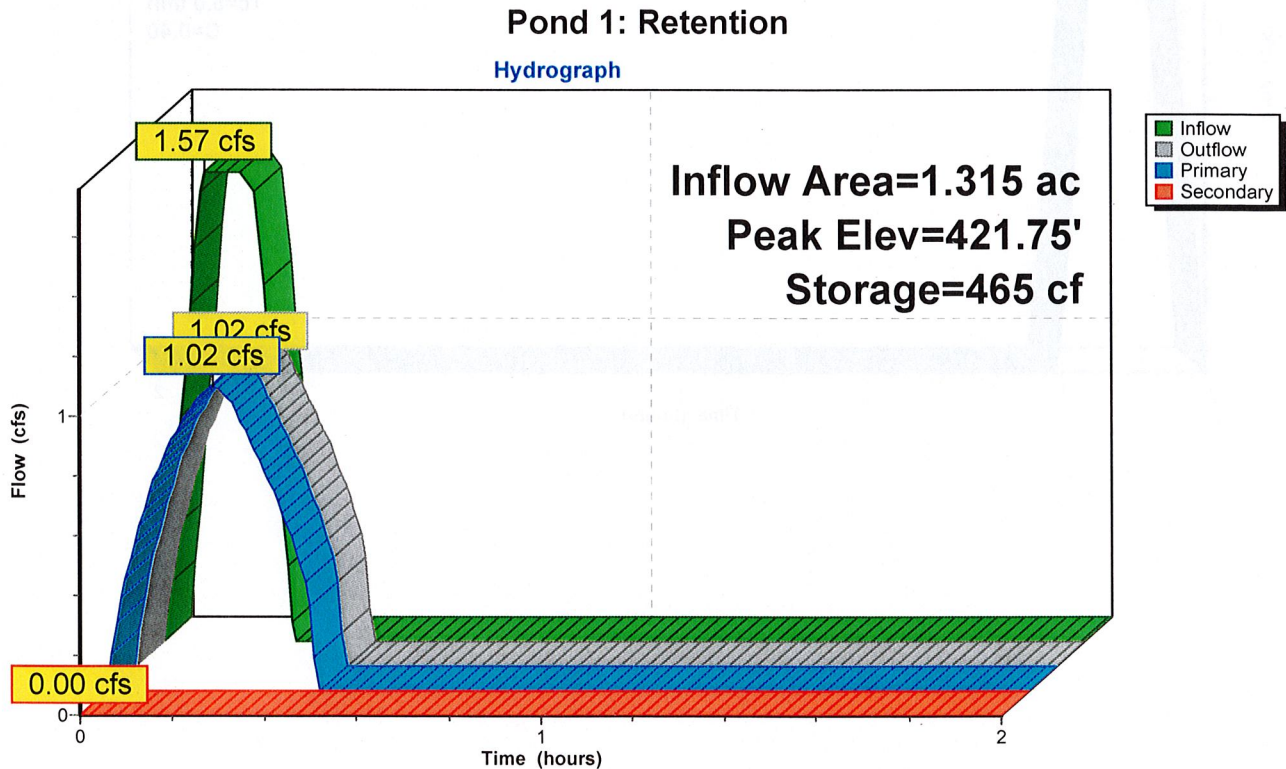
Inflow Area = 1.315 ac, 0.00% Impervious, Inflow Depth = 0.24" for 10-Year event  
 Inflow = 1.57 cfs @ 0.09 hrs, Volume= 0.026 af  
 Outflow = 1.02 cfs @ 0.23 hrs, Volume= 0.026 af, Atten= 35%, Lag= 8.4 min  
 Primary = 1.02 cfs @ 0.23 hrs, Volume= 0.026 af  
 Secondary = 0.00 cfs @ 0.00 hrs, Volume= 0.000 af

**Primary OutFlow** Max=1.02 cfs @ 0.23 hrs HW=421.75' (Free Discharge)  
 ↳ **1=Orifice/Grate** (Orifice Controls 1.02 cfs @ 7.45 fps)

**Secondary OutFlow** Max=0.00 cfs @ 0.00 hrs HW=419.25' (Free Discharge)  
 ↳ **2=Orifice/Grate** ( Controls 0.00 cfs)

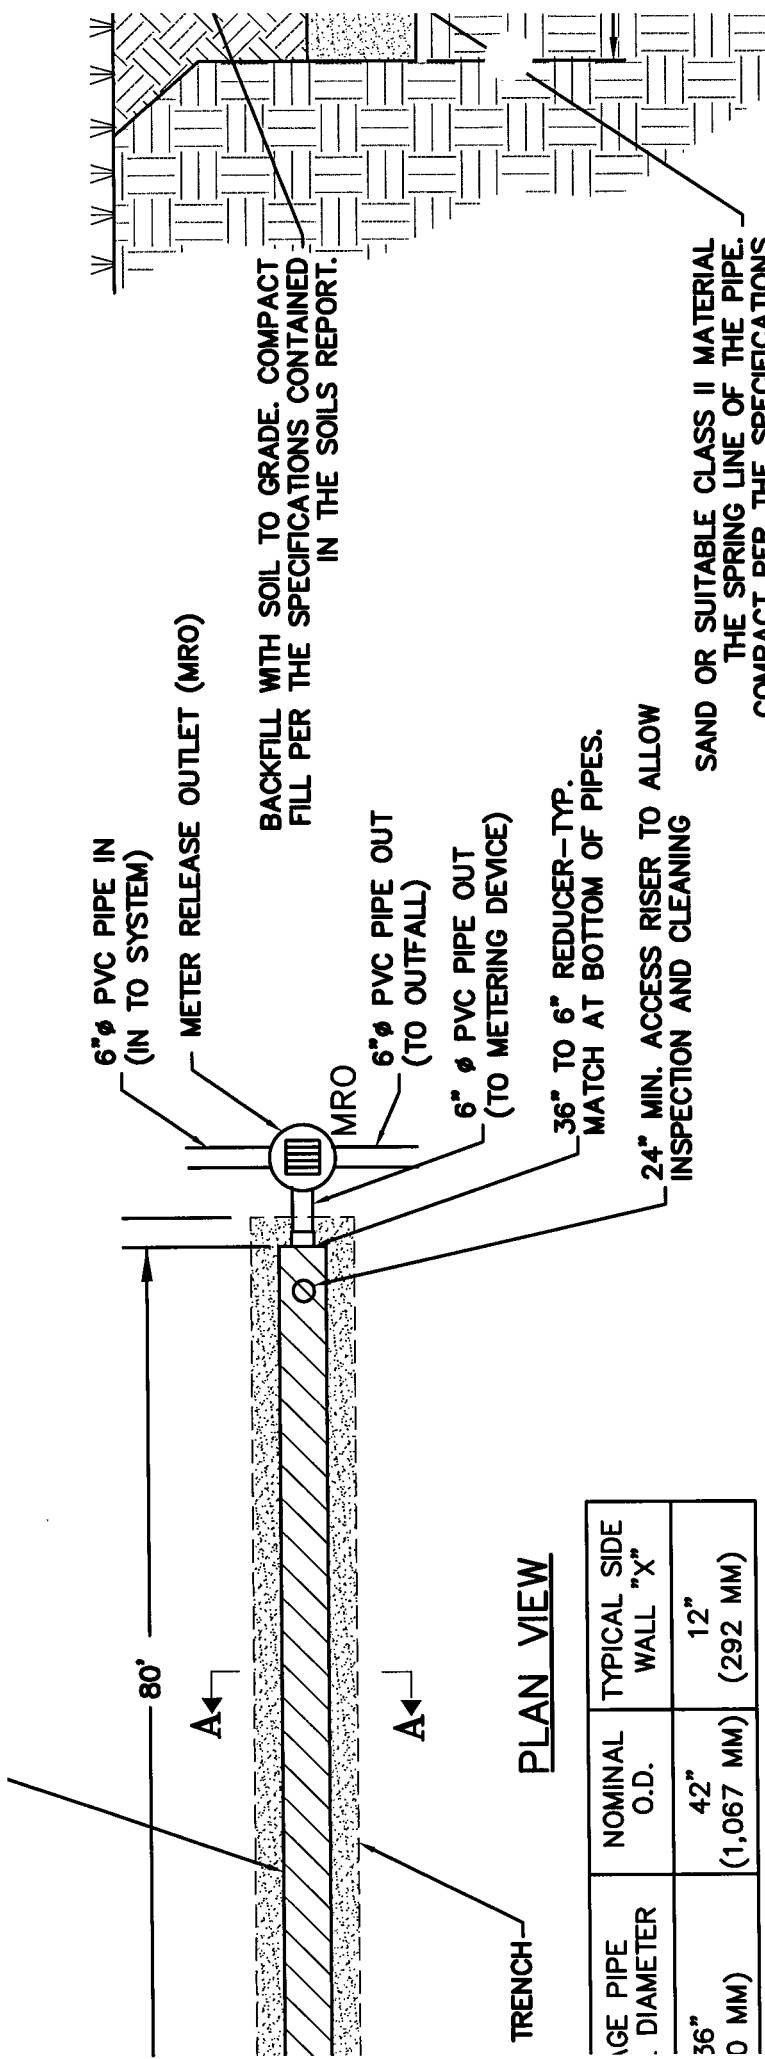
REFERENCES TO CLASS I OR II MATERIAL ARE PER ASTM D2321 "STANDARD FOR UNDERGROUND INSTALLATION OF THERMOPLASTIC PIPE FOR SEWERS AND WASTEWATER APPLICATIONS", LATEST EDITION.

STORM DRAIN SYSTEMS SHALL BE INSTALLED IN ACCORDANCE WITH ASTM D2321, SECTION 10.1.1.1. THE TRENCH SHALL BE INSTALLED IN ACCORDANCE WITH THE INSTALLATION GUIDELINES PUBLISHED BY THE MANUFACTURER'S PUBLISHED INSTALLATION GUIDELINES.

# STORMWATER RETENTION SYSTEM DETAILS
